# Asset Management Plan Sanitary Sewer System

August 2016

Project No. 675-223

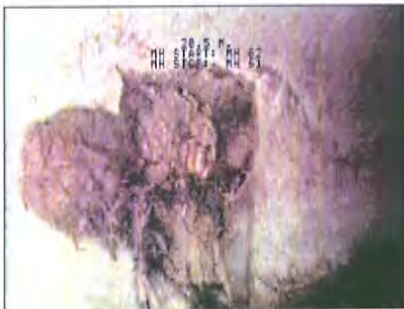
Distance	Length	Code	Reversed	Clock Pos.	Severity	Comment
0.0		MH	No	/		MH 62
0.0		ST	No	/		
0.0		WL	No	/		
0.1		LL	No	/		Slight
0.6		LL	No	/		Slight
0.6		LD	No	/		Slight
7.4		JN	No	10 /		Live.
20.5		SSL	No	8 /		RF from same

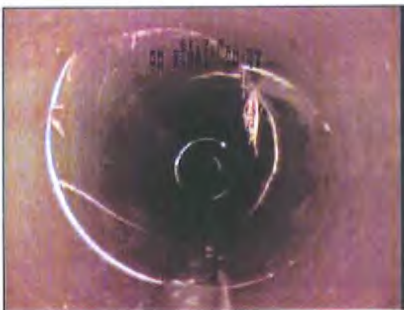
Distance	Length	Code	Reversed	Clock Pos.	Severity	Comment
16.0		JX	No	10 /		Live RF from service
16.7		RFJ	No	/		Trace.
23.9		JN	No	3 /		Live.
28.3		MC	No	/		To PVC
28.3		JDM	No	/		
53.9		JN	No	2 /		Live
54.6		WL	No	/		
55.0		JN	No	12 /		Live.
55.4		MC	No	/		To VC
55.4		WL	No	/		
61.7		FM	No	12 / 12		RF from same

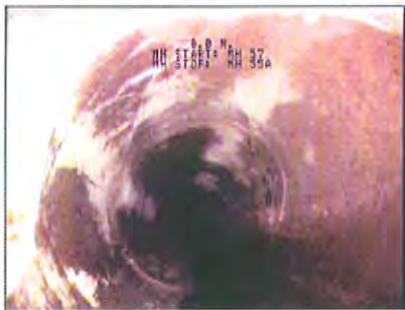
Distance	Length	Code	Reversed	Clock Pos.	Severity	Comment
0.0		ST	No	/		
0.0		MH	No	/		MH 57
0.0		WL	No	/		
0.1		FM	No	12 / 12		From MH interface

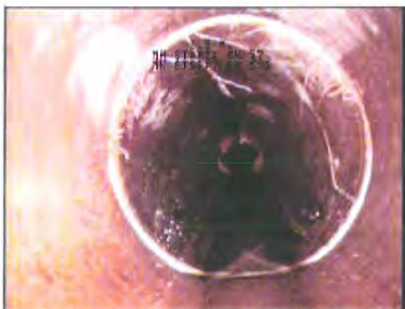
8.2 RFJ No /  
 8.2 FM No 12 / 5 At joint

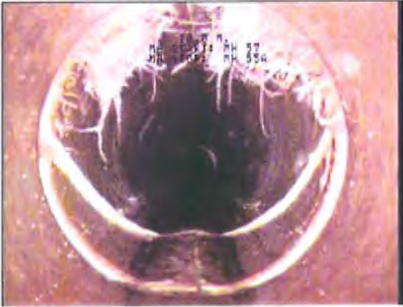
Distance	Length	Code	Reversed	Clock Pos.	Severity	Comment
10.0	RFJ	No	/			
10.0	FM	No	3 / 9

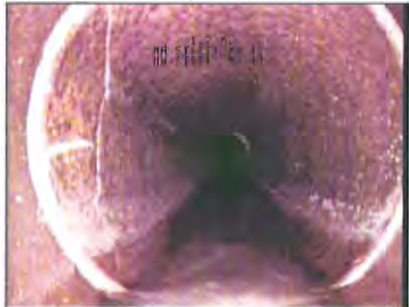
Distance	Length	Code	Reversed	Clock Pos.	Severity	Comment
0.0		MH	No	/		MH 48. FM on riser
0.0		ST	No	/		
0.0		WL	No	/		
1.7		FC	No	7 / 11		At joint

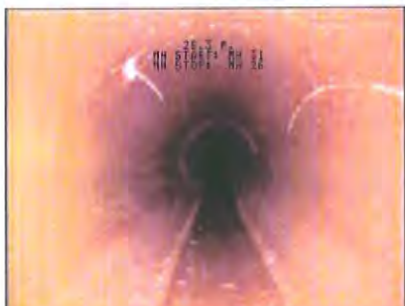
Distance	Length	Code	Reversed	Clock Pos.	Severity	Comment
0.0		MH	No	/		MH 31
0.0		ST	No	/		
0.0		WL	No	/		
11.5		WL	No	/		
17.0		WL	No	/		
21.2		JN	No	4 /		Live. Backgraded
28.2		CM	No	9 / 3

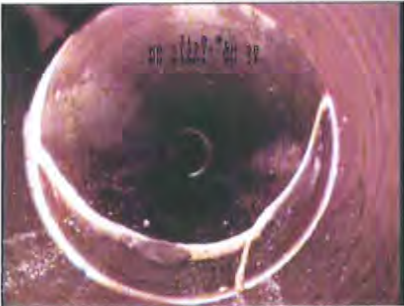
Distance	Length	Code	Reversed	Clock Pos.	Severity	Comment
0.0		ST	No	/		
0.0		MH	No	/		MH 28
0.0		WL	No	/		
4.3		JN	No	2 /		Live.
31.0		FM	No	2 / 9		At joint. Pipe displaced

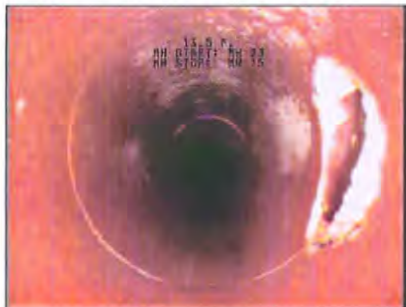
Distance	Length	Code	Reversed	Clock Pos.	Severity	Comment
0.0		MH	Yes	/		MH 23
0.0		ST	Yes	/		
0.0		WL	Yes	/		
13.5		CX	Yes	3 /		Live. CC from same.

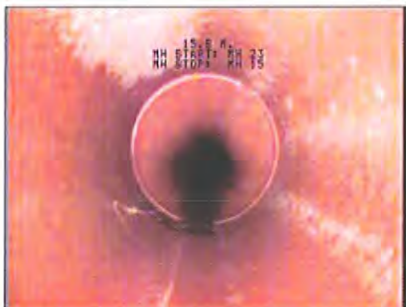
15.8 FL Yes 6 / 8 From joint

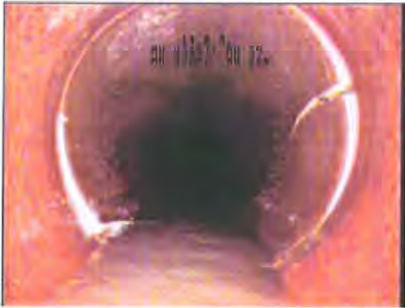
Distance	Length	Code	Reversed	Clock Pos.	Severity	Comment
0.0		ST	No	/		
0.0		MH	No	/		MH 39
0.0		WL	No	/		
3.3		WL	No	/		Varies 5-15%
9.0		JN	No	2 /		Live. Trickle flow
19.0		FM	No	2 / 7		At joint

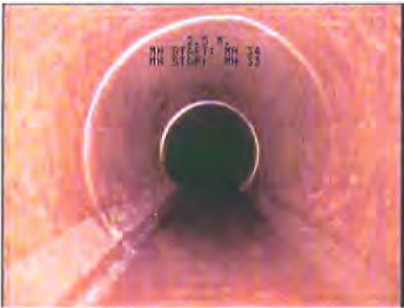
Distance	Length	Code	Reversed	Clock Pos.	Severity	Comment
0.0		MH	No	/		MH 34
0.0		ST	No	/		
0.0		WL	No	/		Varies to 15%
2.5		FC	No	12 / 12

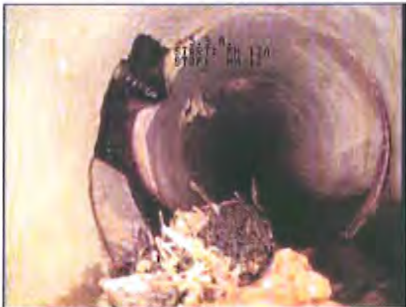
5.9		DE	No	/		
6.2		H	No	10 / 12		Two small holes
