Regular Meeting of Council

Village of Clinton Council Chambers, 1423 Cariboo Highway
Wednesday, May 14, 2025 at 6:30 pm

Subject: Hazard Land Development Permit Report – 409 Lebourdais Ave & 1500 Engeman Lane

Geohazard Assessment in Support of a Subdivision Application to Alter an Internal Lot Boundary

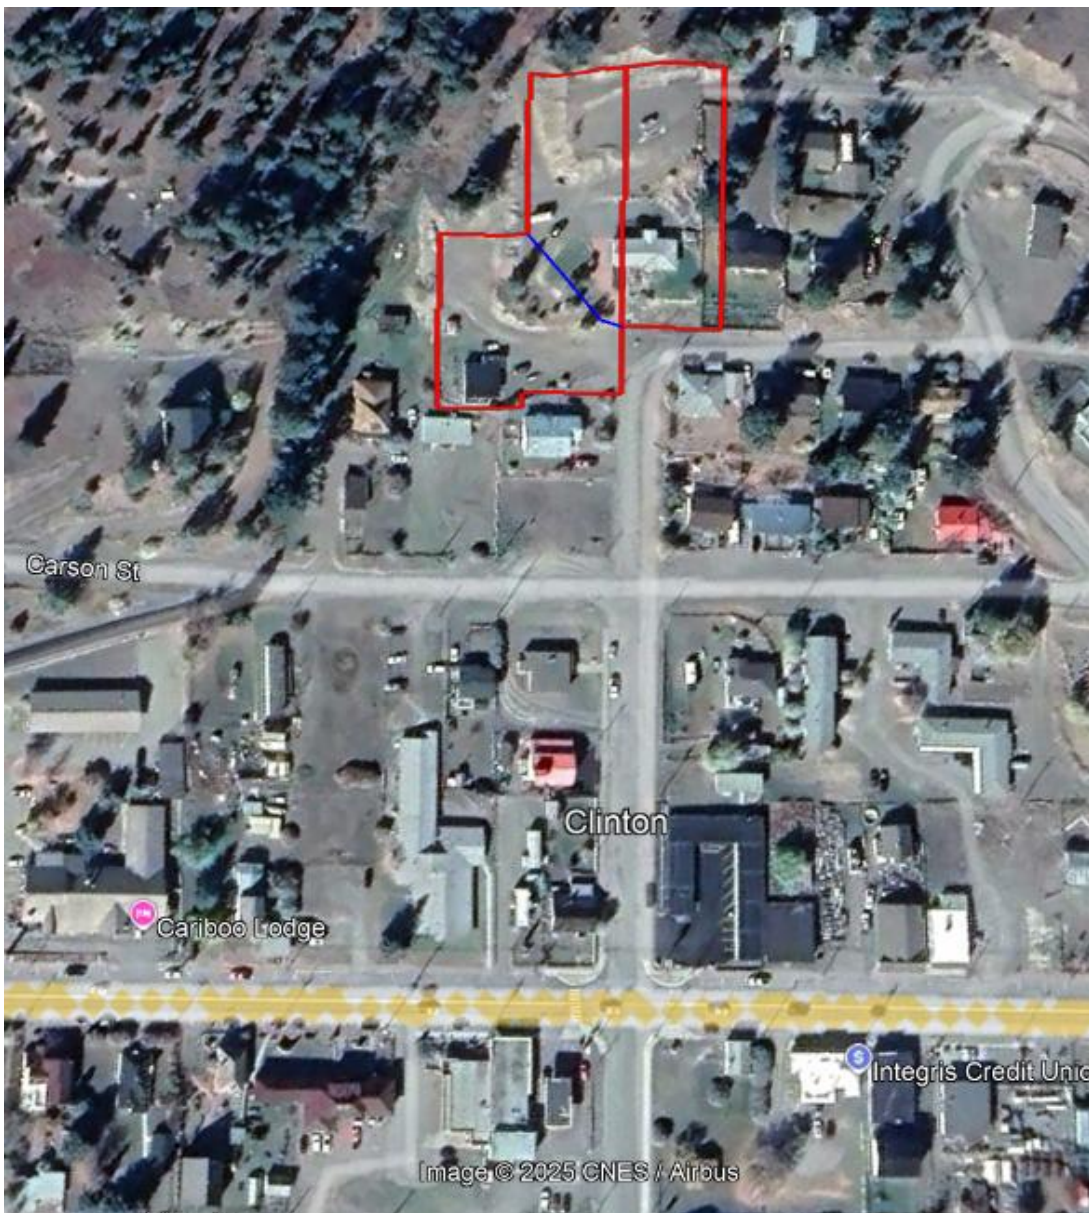
Figure 1: Proposed Subdivision – Existing lot lines in red, lot line in blue proposed to amend the dividing line between the properties.

Mr. John White (*The Applicant*), the owner of 409 Lebourdais Ave & 1500 Engeman Lane has submitted an application for a subdivision to amend the location of the lot line between the properties to follow the natural terraced slope. The below image shows the proposed subdivision. Existing lot lines are in red, the proposed amended lot line in blue would replace the existing line dividing the properties.

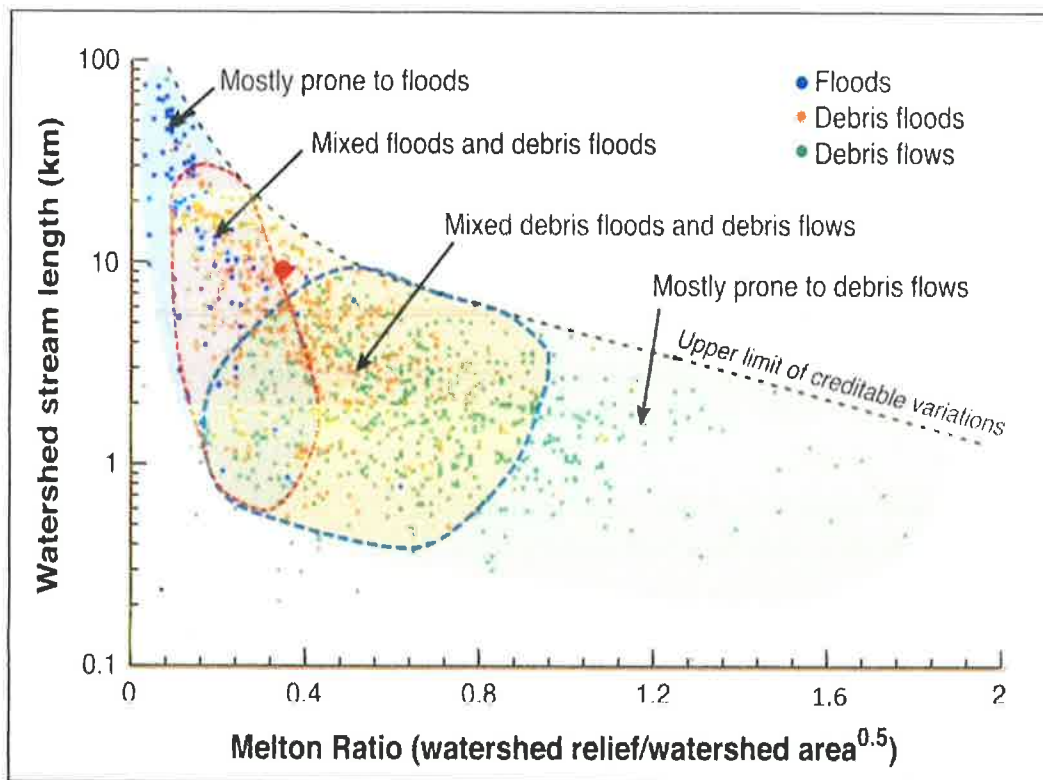
Figure 5: Hydrogeomorphic processes as a function of the Melton ratio and stream length (Church and Jakob, 2020).
The derived Soues Creek watershed plots near the border of the “mixed floods and debris floods” category (red marker).

Wilford *et al.* (2004) used the following morphometrics to predict the dominant hydrogeomorphic hazard(s) that could be expected within a watershed:

The results of the morphometric analysis are further supported by the gradient of the base of the gully upstream from the Properties, which averages 10% over a distance of approximately 9.2 km, which is not steep enough to initiate or result in prolonged transport of a debris flow. That is, Takahashi (1991)²⁰ states that debris flows require channel gradients in excess of 27% for prolonged transport and may continue at lower gradients under 20%, but they tend to lose momentum and begin to transition to deposition. The average slopes for debris floods and floods tend to be much lower than those for debris flows²¹.

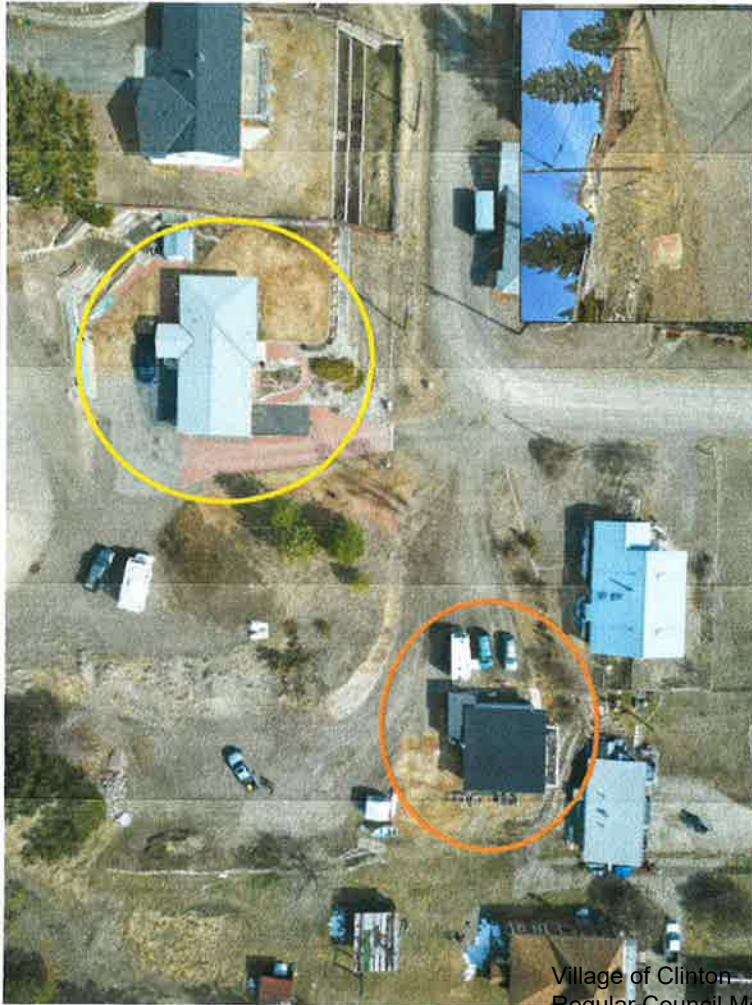
Photo 1: Aerial view of the existing houses on each lot. Lot 1 (1500 Engeman Lane) is circled yellow, and Lot 5 (409 Lebourdais Ave) is circled orange. The gully outlet is to the top left of the picture. The inset photo shows the landscaped walls and slope below the house on Lot 1.

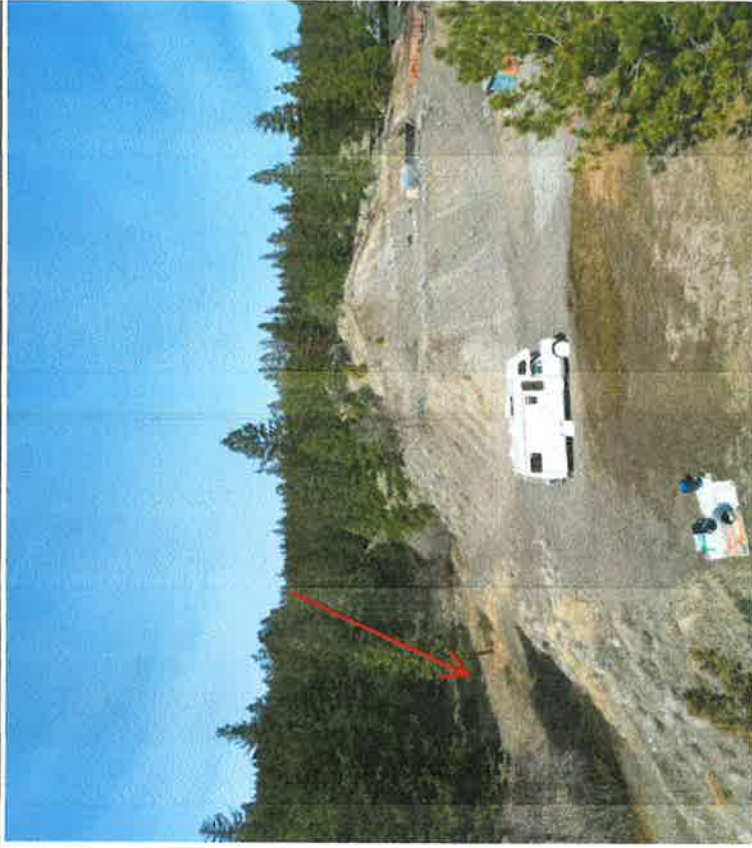
Photo 2: The ravelling cut slopes behind the house on Lot 1 exposing well-drained cobbly sand with trace to some silt, as well as eo

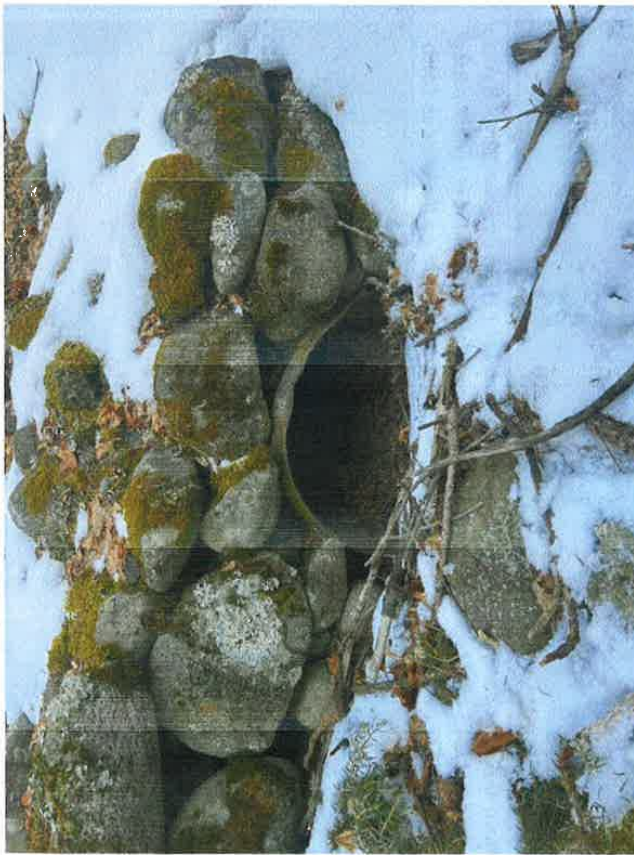
Photo 7: A 400 mm diameter CMP culvert located at the base of the embankment. Debris has infilled approximately 1/3 of the culvert.

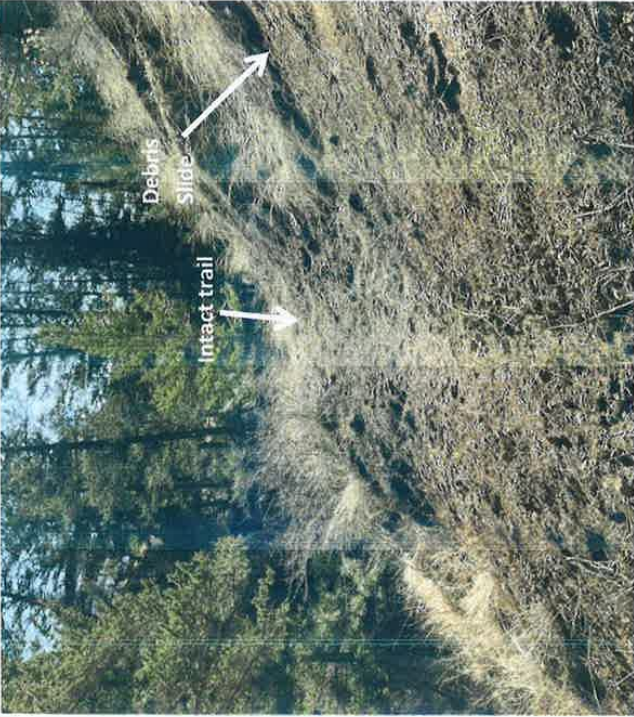
Photo 8: Very small debris slide on the western side of the gully, about 200 m the Properties.

remains intact. Silt and fine-grained sand are exposed in the headscarp, and are interpreted to be eolian deposits. The terrain upslope of the headscarp is ridged, with no visible signs of seepage or concentration of runoff to this area. Below, the gully has a basal width of approximately 6 m and a gradient of about 10%. No significant signs of active erosional scour were evident, although surface conditions were partially obscured by patchy snow cover.

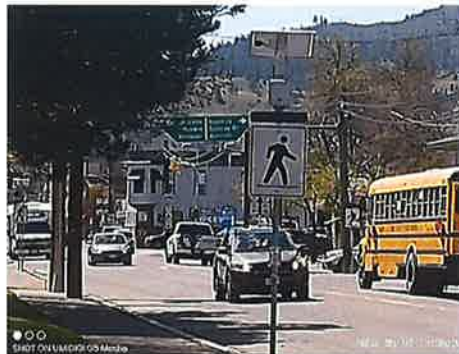
Solar panel pedestrian crossing signs. They are all along Voght St.

Interested to see if we could have something like this at LeBourdais Ave and the Hwy.
