# Asset Management Plan Sanitary Sewer System

August 2016

Project No. 675-223

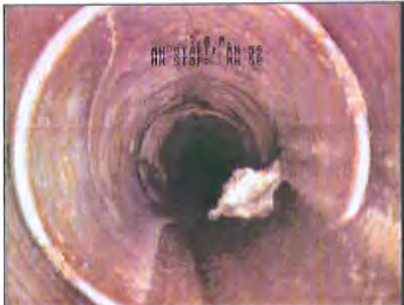
Distance	Length	Code	Reversed	Clock Pos.	Severity	Comment
0.0		ST	No	/		
0.0		MH	No	/		MH 59. Wet benching
0.0		WL	No	/		
7.0		FM	No	6 / 12		From joint DS 1M

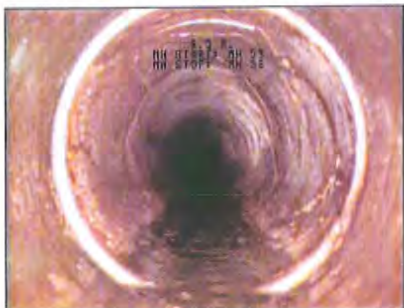
8.5 FM No 12 / 12

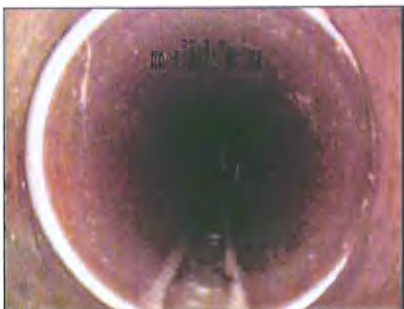
72.3	CC	No	9 / 11	At joint
------	----	----	--------	----------

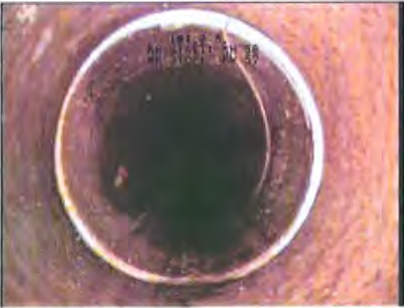
Distance	Length	Code	Reversed	Clock Pos.	Severity	Comment
0.0		ST	No	/		
0.0		MH	No	/		MH 58
0.0		WL	No	/		
3.3	14.7	EL	No	2 / 10		Soft, wet. Varies
24.0		JN	No	10 /		Live. Light flow
32.4		JN	No	10 /		Capped
66.9		JN	No	10 /		Live.
92.3		JN	No	3 /		Appears unused
104.0		FM	No	1 / 6		At joint

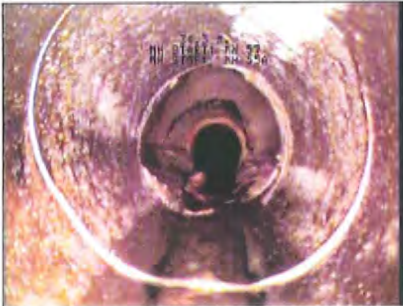
15.9	JN	No	10 /			Live. Light flow
34.3	FM	No	12 / 12			To MH interface

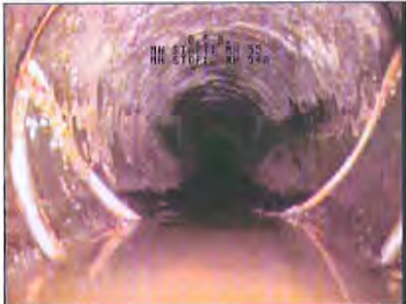
Distance	Length	Code	Reversed	Clock Pos.	Severity	Comment
0.0		ST	No	/		
0.0		MH	No	/		MH 55
0.0		WL	No	/		
0.5		FC	No	2 / 10		At joint. Pipe displaced

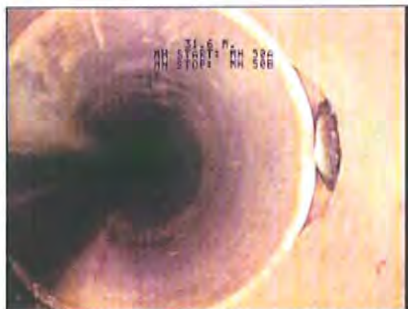
Distance	Length	Code	Reversed	Clock Pos.	Severity	Comment
0.0		MH	Yes	/		MH 50A. No MH # on plan
0.0		ST	Yes	/		
0.0		WL	Yes	/		
31.6		SSL	Yes	1 /		At joint. Gasket visible

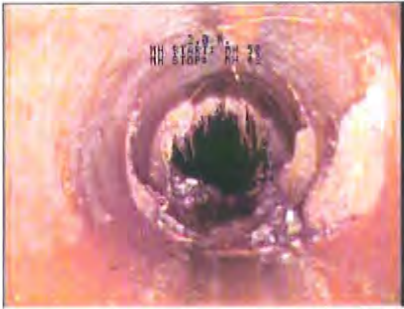
Distance	Length	Code	Reversed	Clock Pos.	Severity	Comment
0.0		MH	No	/		MH 50
0.0		ST	No	/		
0.0		WL	No	/		
2.0		FM	No	12 / 12		RF from same

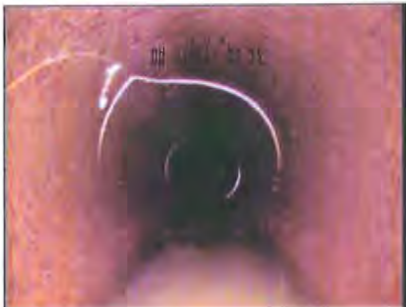
Distance	Length	Code	Reversed	Clock Pos.	Severity	Comment
0.0		ST	No	/		
0.0		MH	No	/		MH 46
0.0		WL	No	/		Varies to 10%
1.4		FM	No	12 / 12

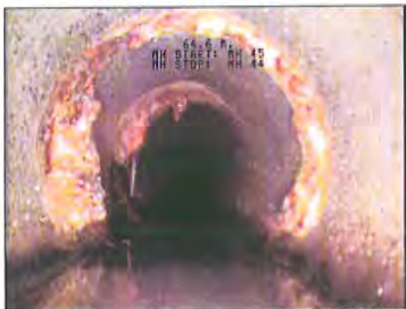
Distance	Length	Code	Reversed	Clock Pos.	Severity	Comment
0.0		ST	No	/		
0.0		MH	No	/		MH 45
0.0		WL	No	/		Varies to 10%
0.1		EL	No	5 / 7		
1.0		CNI	No	3 /		Live.
3.9		CN	No	11 /		Appears unused
23.1		CN	No	2 /		Live.
31.0		CX	No	10 /		Live. Light flow. Saddle leak
37.8		CX	No	10 /		Live. EM at interface
50.8		CN	No	12 /		Live. Dripping
54.6		DES	No	/		
61.4		CX	No	2 /		Live. 30% DE from service
63.0		WL	No	/		
64.6		FC	No	12 / 12		EM, IG from same

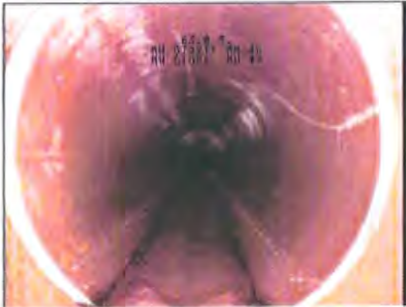
Distance	Length	Code	Reversed	Clock Pos.	Severity	Comment
0.0		ST	Yes	/		
0.0		MH	Yes	/		MH 46
0.0		WL	Yes	/		
3.5		JN	Yes	2 /		Appears unused
23.2		JN	Yes	3 /		Appears unused
37.2		JN	Yes	2 /		Appears unused
45.5		JN	Yes	10 /		Live. Light flow
63.0		CL	Yes	3 /		At joint

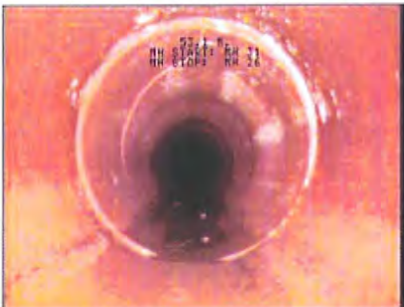
38.7	JN	No		3 /		Live.
41.2	JN	No		9 /		Live.
53.1	FM	No		5 / 2		At joint. Spiral

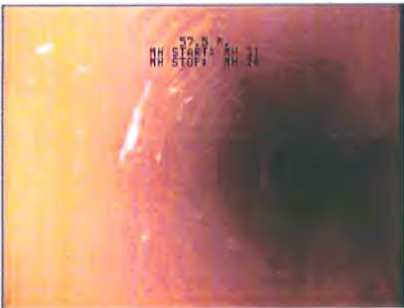
53.1	CM	No		6 / 4

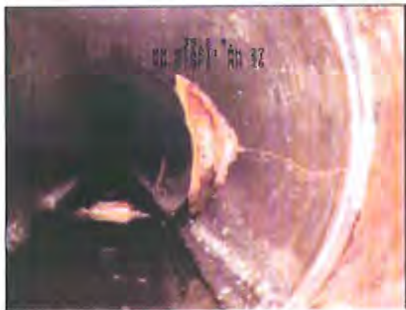
Distance	Length	Code	Reversed	Clock Pos.	Severity	Comment
0.0		ST	No	/		
0.0		MH	No	/		MH 27
0.0		WL	No	/		Varies to 10%
23.8		JN	No	2 /		Appears unused
35.8		CL	No	3 /		Joint to service

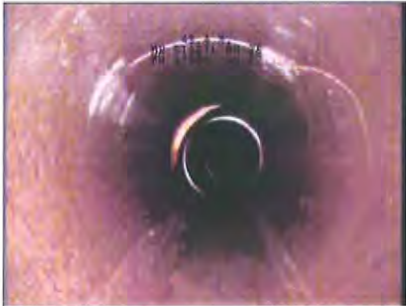
Distance	Length	Code	Reversed	Clock Pos.	Severity	Comment
0.0		ST	No	/		
0.0		MH	No	/		MH 26
0.0		WL	No	/		
16.9		JN	No	2 /		Live.
48.4		FC	No	8 / 4

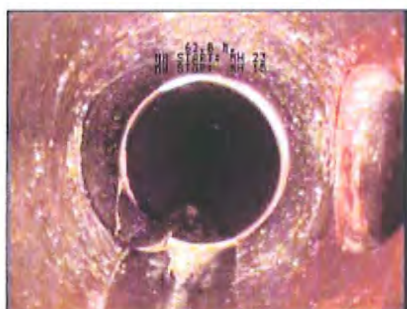
Distance	Length	Code	Reversed	Clock Pos.	Severity	Comment
25.9		JN	Yes	3 /		Live.
43.7		JN	Yes	10 /		Live.
46.1		JN	Yes	3 /		Live.
61.7		CNI	Yes	10 /		Live.
62.0		JN	Yes	2 /		Appears unused
62.0		B	Yes	5 / 1		At joint

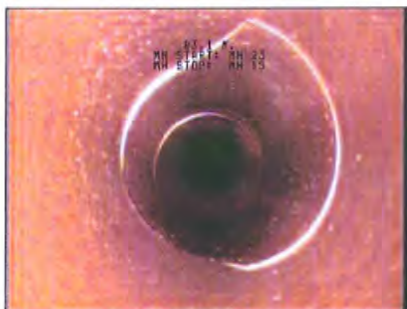
64.6	JN	Yes	9 /		Capped
83.1	FC	Yes	12 / 12

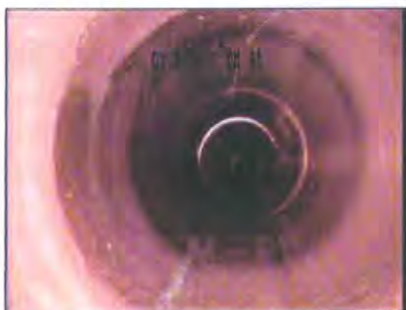
Distance	Length	Code	Reversed	Clock Pos.	Severity	Comment
0.0		ST	No	/		
0.0		MH	No	/		MH 36
0.0		WL	No	/		
11.1		JN	No	3 /		Live.
21.1		JN	No	9 /		Live
22.3		CL	No	9 / 1		Spiral

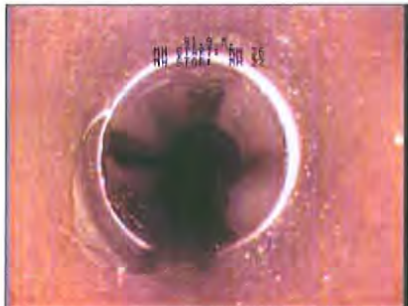
Distance	Length	Code	Reversed	Clock Pos.	Severity	Comment
0.0		ST	Yes	/		
0.0		MH	Yes	/		MH 36
0.0		WL	Yes	/		Varies to 15%
1.5		JN	Yes	9 /		Appears unused
4.3		JN	Yes	2 /		Live.
25.9		JN	Yes	9 /		Live.
36.2		JN	Yes	2 /		Live.
44.5		JN	Yes	9 /		Appears unused
66.2		JN	Yes	2 /		Capped
70.7		JN	Yes	9 /		Live.
81.9		FM	Yes	5 / 10		At joint

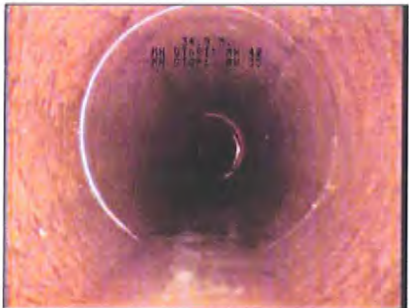
34.9	CC	Yes	12 / 12

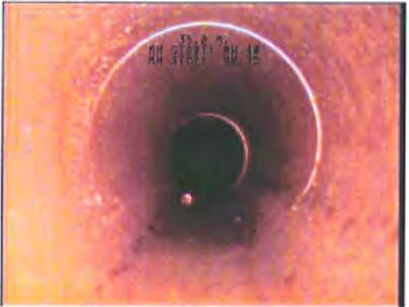
36.3	CN	Yes	3 /			Live.
39.0	CC	Yes	12 / 12

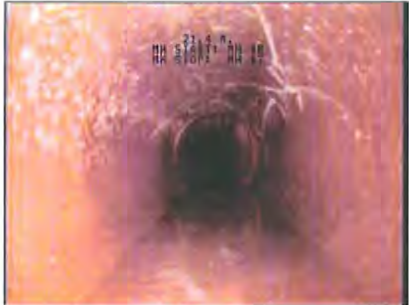
Distance	Length	Code	Reversed	Clock Pos.	Severity	Comment
0.0		MH	Yes	/		MH 40
0.0		ST	Yes	/		
0.0		WL	Yes	/		
0.1		GO	Yes	/		Point repair for 1M
18.5		JN	Yes	2 /		Appears unused
18.8		GO	Yes	/		Point repair for 2M
21.4		CM	Yes	9 / 3

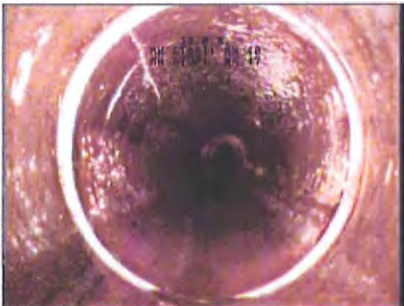
38.0	CL	Yes	10 /			From joint

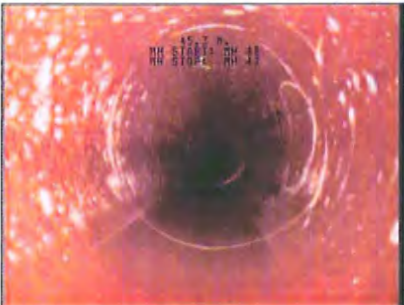
40.5	JN	Yes	2 /			Live.
45.3	CM	Yes	12 / 12

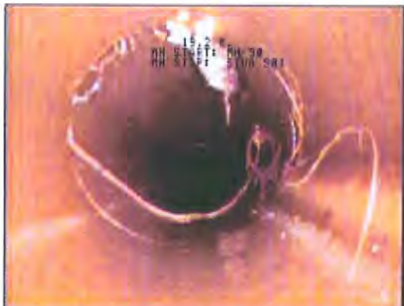
Distance	Length	Code	Reversed	Clock Pos.	Severity	Comment
0.0		MH	Yes	/		MH 50
0.0		ST	Yes	/		
0.0		WL	Yes	/		
7.5		WL	Yes	/		
7.5		DES	Yes	/		
9.0		WL	Yes	/		
19.2		FM	Yes	12 / 12		RF from same

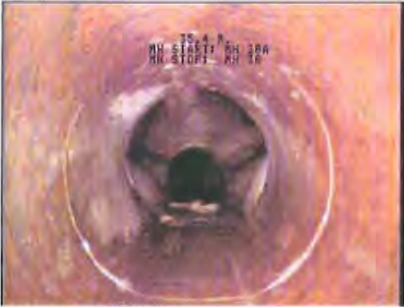
Distance	Length	Code	Reversed	Clock Pos.	Severity	Comment
0.0		ST	No	/		
0.0		MH	No	/		MH 38A. Tight benching.
0.0		WL	No	/		
0.0		GO	No	/		Pipe is AC at MH
9.0		WL	No	/		
11.3		WL	No	/		
22.7		JN	No	2 /		Appears unused
35.4		FC	No	12 / 12		At interface

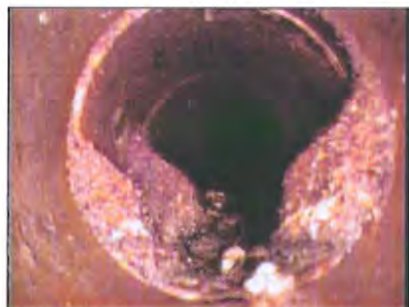
Distance	Length	Code	Reversed	Clock Pos.	Severity	Comment
0.0		ST	No	/		
0.0		MH	No	/		MH 18
0.0		WL	No	/		
0.3		RFJ	No	/		Root tail for 0.4M
0.3		FM	No	12 / 12		DS of joint

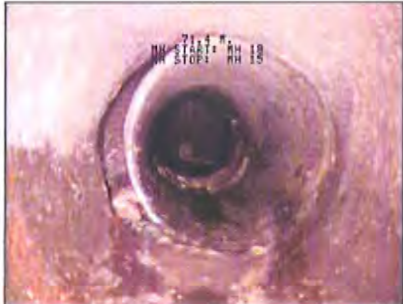
Distance	Length	Code	Reversed	Clock Pos.	Severity	Comment
41.8	JN	No		2 /		Live.
71.4	H	No		5 / 11		At joint. Fill visible

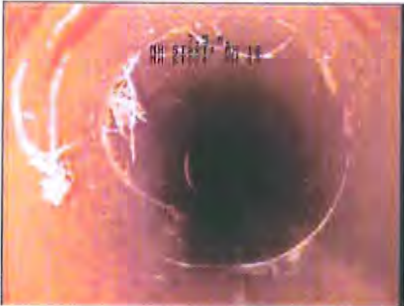
Distance	Length	Code	Reversed	Clock Pos.	Severity	Comment
0.0		MH	Yes	/		MH 18
0.0		ST	Yes	/		
0.0		WL	Yes	/		
6.7		JN	Yes	10 /		Live. Light flow
6.8		RFJ	Yes	/		Trace.
7.5		FM	Yes	12 / 12		RF from same

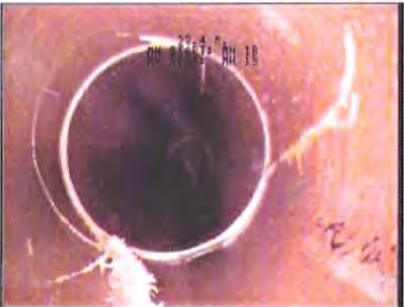
25.6	6.4	RFJ	Yes	/		Root tail. Varies
27.3		FC	Yes	7 / 1		At joint

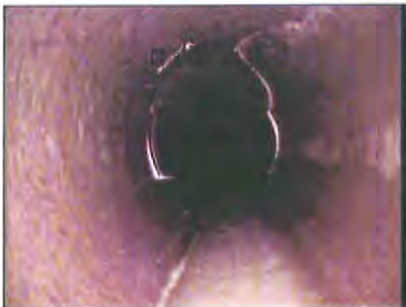
Distance	Length	Code	Reversed	Clock Pos.	Severity	Comment
0.0		ST	Yes	/		
0.0		MH	Yes	/		MH 14
0.0		WL	Yes	/		
13.6		CN	Yes	12 /		Appears live but unused
23.3		JN	Yes	3 /		Live.
29.5		CN	Yes	2 /		Live.
46.6		JN	Yes	2 /		Live.
54.9		JN	Yes	10 /		Live.
72.6		FM	Yes	12 / 12

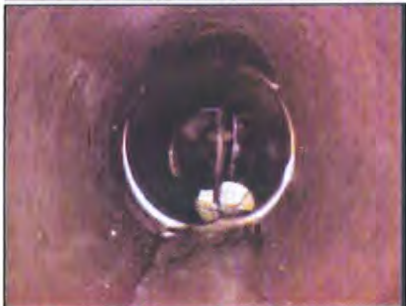
81.6	OB	Yes	/			Stick lodged in MH
81.8	MH	Yes	/			MH 15
81.9	FH	Yes	/

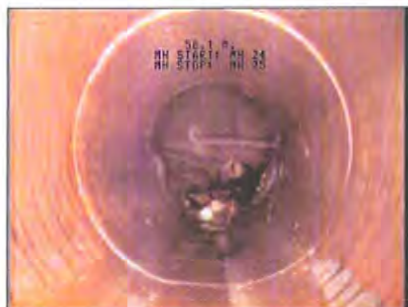
Distance	Length	Code	Reversed	Clock Pos.	Severity	Comment
0.0		ST	Yes	/		
0.0		MH	Yes	/		MH 24
0.0		WL	Yes	/		
6.4		CNI	Yes	1 /		Live.
17.7		WL	Yes	/		
19.7		JN	Yes	2 /		Live.
19.7		WL	Yes	/		
26.6		WL	Yes	/		
48.2		CN	Yes	2 /		Live. Light flow
49.2		WL	Yes	/		Varies 5-15%
58.1		FC	Yes	12 / 12

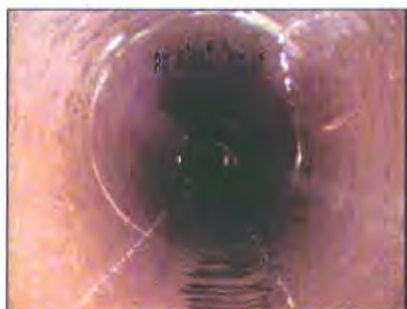
Distance	Length	Code	Reversed	Clock Pos.	Severity	Comment
0.0		ST	Yes	/		
0.0		MH	Yes	/		MH 16
0.0		WL	Yes	/		
8.4		JN	Yes	3 /		Appears unused
20.7		JN	Yes	9 /		Appears unused. DES
26.8		JN	Yes	3 /		Live.
42.6		FM	Yes	12 / 12

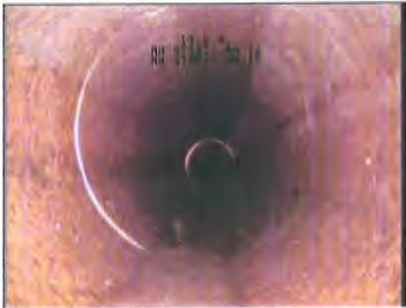
Distance	Length	Code	Reversed	Clock Pos.	Severity	Comment
0.0		MH	No	/		MH 16
0.0		ST	No	/		
0.0		WL	No	/		
9.7		WL	No	/		
12.0		WL	No	/		Varies to 15%
19.6		FC	No	12 / 12

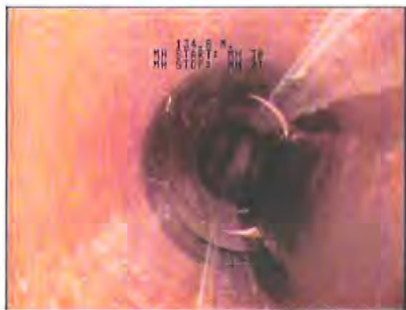
Distance	Length	Code	Reversed	Clock Pos.	Severity	Comment
0.0		ST	No	/		
0.0		MH	No	/		MH 30
0.0		WL	No	/		
0.3		FC	No	12 / 12		Not on video
0.3		WL	No	/		
4.5		WL	No	/		Varies to 15%
35.4		JN	No	3 /		Appears unused
64.6		JN	No	2 /		Live.
82.5		JN	No	10 /		Live. Trickle flow
92.8		JN	No	3 /		Live.
99.3		JN	No	10 /		Live.
134.8		FM	No	12 / 12		Pipe displaced. Fill visible

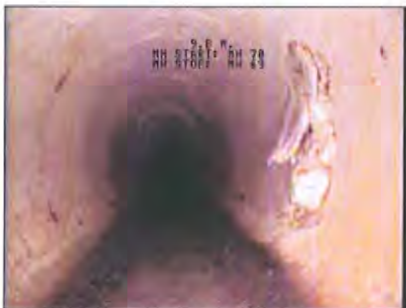
Distance	Length	Code	Reversed	Clock Pos.	Severity	Comment
0.0		ST	No	/		
0.0		MH	No	/		MH 70
0.0		WL	No	/		
8.5		JN	No	10 /		Live. OJM in service
9.8		SSL	No	2 / 4

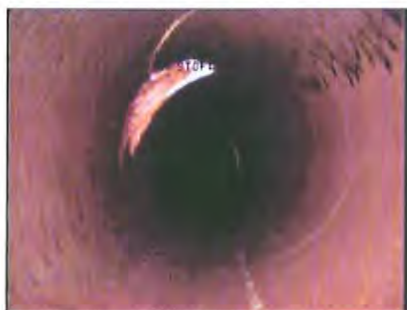
Distance	Length	Code	Reversed	Clock Pos.	Severity	Comment
0.0		ST	Yes	/		
0.0		MH	Yes	/		MH 10
0.0		WL	Yes	/		
5.2		JN	Yes	2 /		Appears unused.
8.8		CN	Yes	3 /		Live. Trickle flow
13.3		CNI	Yes	3 /		Live.
20.3		CN	Yes	9 /		Live.
22.4		JN	Yes	3 /		Appears unused. DES
48.6		CN	Yes	10 /		Live. FC in service
64.3		FC	Yes	11 / 9		From service

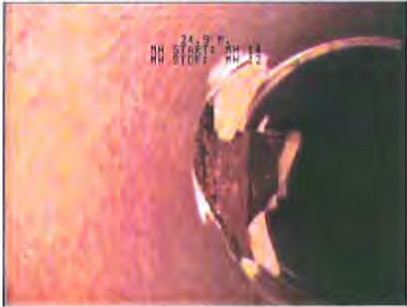
Distance	Length	Code	Reversed	Clock Pos.	Severity	Comment
0.0		ST	No	/		
0.0		MH	No	/		MH 14
0.0		WL	No	/		
21.6		JN	No	3 /		Live. Light flow
22.6		JN	No	9 /		Capped
23.0		CN	No	9 /		Appears unused
24.7		H	No	11 / 1		Appears repaired

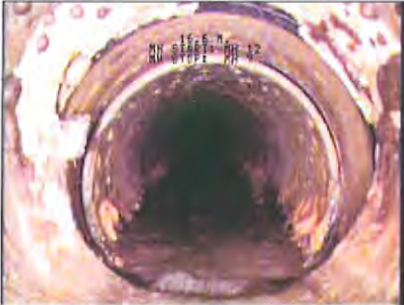
Distance	Length	Code	Reversed	Clock Pos.	Severity	Comment
0.0		MH	No	/		MH 12
0.0		ST	No	/		
0.0		WL	No	/		
13.3		CN	No	2 /		Live.
16.6		JDL	No	/

17.0		SA	No	/		Cannot pass JDL

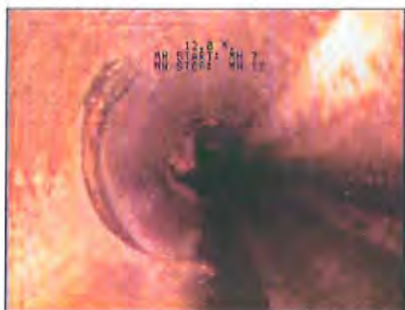
Distance	Length	Code	Reversed	Clock Pos.	Severity	Comment
0.0		ST	Yes	/		
0.0		MH	Yes	/		MH 7
0.0		WL	Yes	/		
12.0		SSM	Yes	12 /		Stained

12.6		EMJ	Yes	/		Possible crack
13.5		MH	Yes	/		MH 7B. Unplotted
13.5		GO	Yes	/		IS, EL in MH
33.6		CN	Yes	10 /		Live.
64.7		SSS	Yes	2 /		EL from same

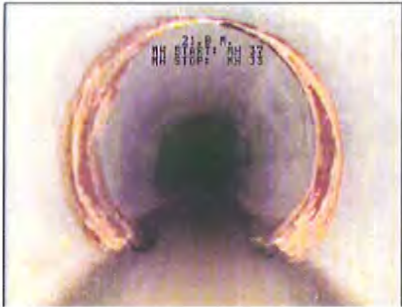
Distance	Length	Code	Reversed	Clock Pos.	Severity	Comment
0.0		ST	No	/		
0.0		MH	No	/		MH 37. EL from barrel
0.0		WL	No	/		Varies to 10%
21.8		FC	No	12 / 12		EL from same

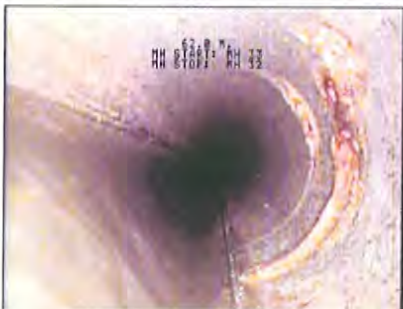
Distance	Length	Code	Reversed	Clock Pos.	Severity	Comment
0.0		MH	No	/		MH 33
0.0		ST	No	/		
0.0		WL	No	/		Varies to 15%
6.9		CN	No	1 /		Live.
31.3		CN	No	2 /		Live.
37.4		CX	No	2 /		Live. Stained at interface
43.2		CN	No	10 /		Live.
53.7		CN	No	10 /		Live.
61.6		CN	No	1 /		Live.
62.0		H	No	12 / 1		Three. Stained
